SR100 & SR150 BIG GUN® Drive Arm & Counterweight Maintenance Kit Instructions

Part Number 9822

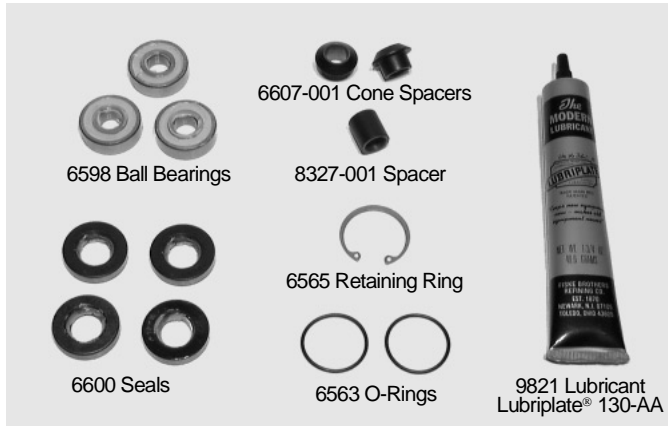
Figure 1 Parts Supplied in Maintenance Kit.

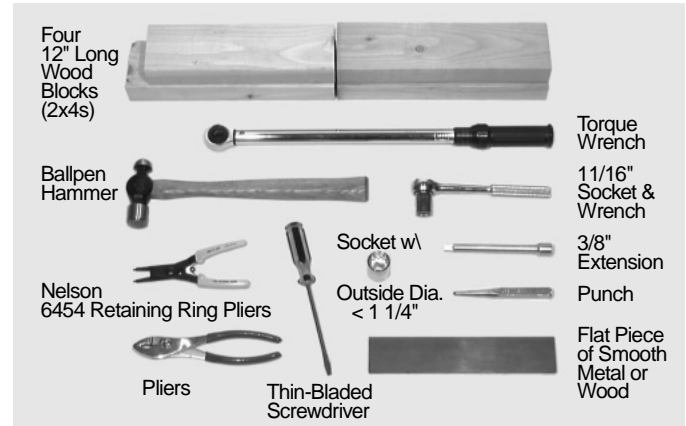
Figure 2 Tools Required to Install Maintenance Kit.

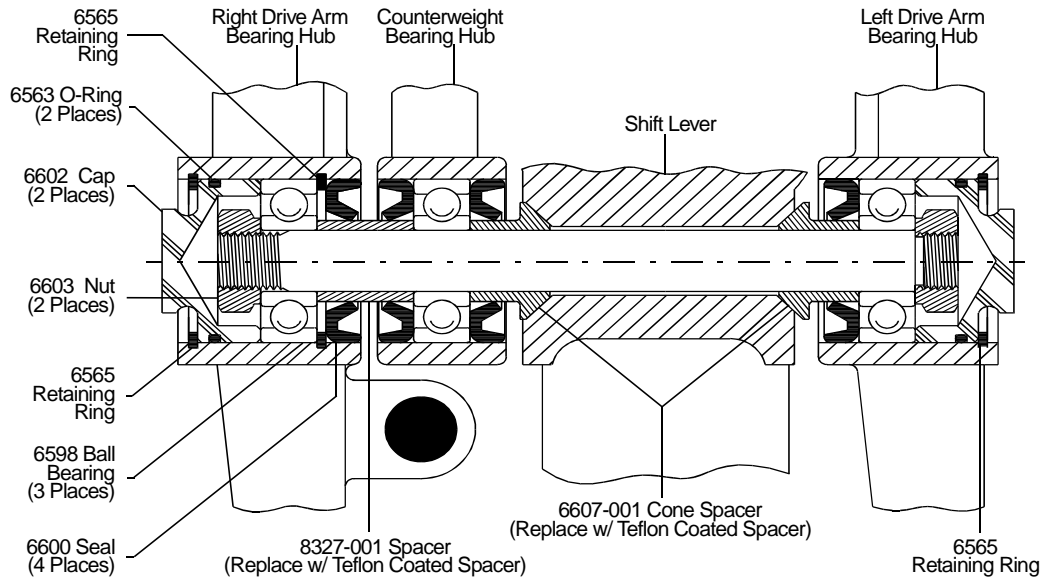
Figure 3 Section View of Drive Arm and Counter Weight Assembly.

IMPORTANT: Bore of right drive arm bearing hub contains retaining ring 6565. As shown in Figure 3, this retaining ring is located between 6600 seal and 6598 ball bearing. If bearing is driven towards seal with retaining ring in place, damage to drive arm hub will result!

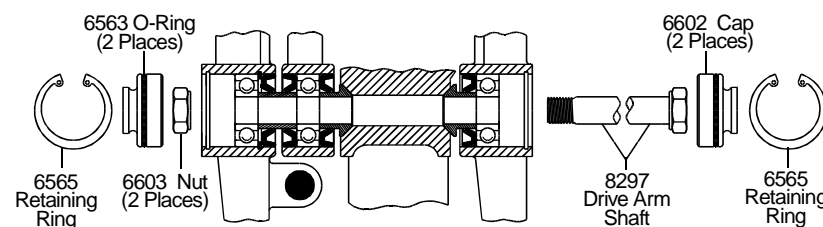
Figure 4 Same View as Figure 3 with Exploded View Added.

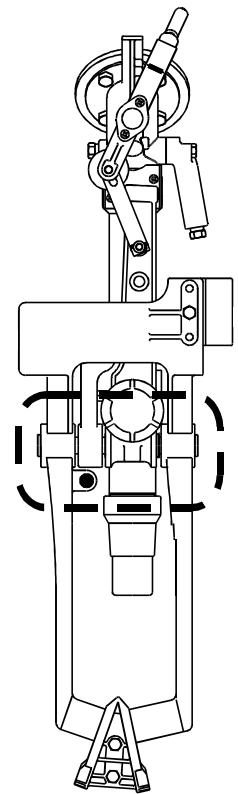
Figure 5 Area Shown in Section Views in Figure 3 and Figure 4.

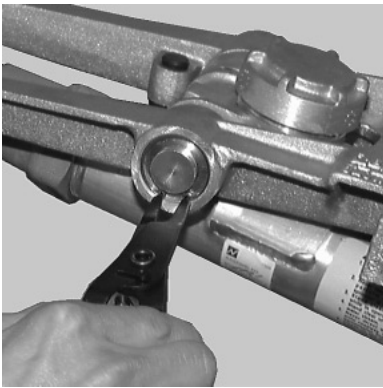
Figure 6

Using 6454 retaining ring pliers, remove two 6565 retaining rings, one from left drive arm bearing hub and one from right drive arm bearing hub (see Figure 6). Using pliers, remove one 6602 end cap from each hub. Using two socket wrenches fitted with 11/16" sockets, one at each end of 8297 drive arm shaft, remove 6603 nut from one end of shaft. Push shaft in until opposite end can be grasped by nut and pull shaft completely out of assembly. Remove remaining nut from shaft and roll shaft on flat surface to check for straightness. If bent, replace shaft.

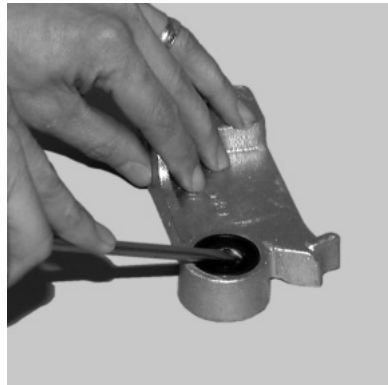
Figure 9

Remove 6607-001 cone spacer from counterweight. As shown in Figure 9, insert thin screwdriver blade under lip of 6600 seal and pry seal out. Turn counterweight over and remove opposite seal in same manner.

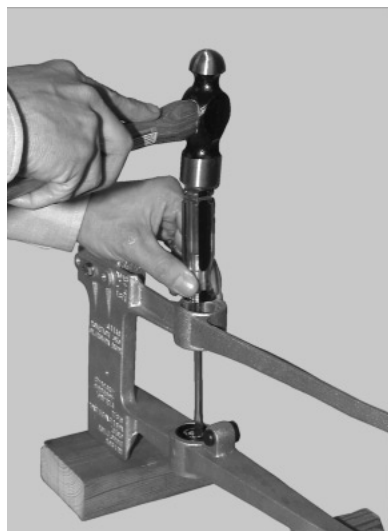
Figure 11

Remove 6607-001 cone spacer from left drive arm bearing hub. Working from seal side of drive arm hubs, use finger pressure to push one 6598 ball bearing from each hub. When originally installed, bearings are a slip fit. If finger pressure will not remove bearings, position drive arm as shown in Figure 11. Using a screwdriver and hammer, lightly tap bearings out.

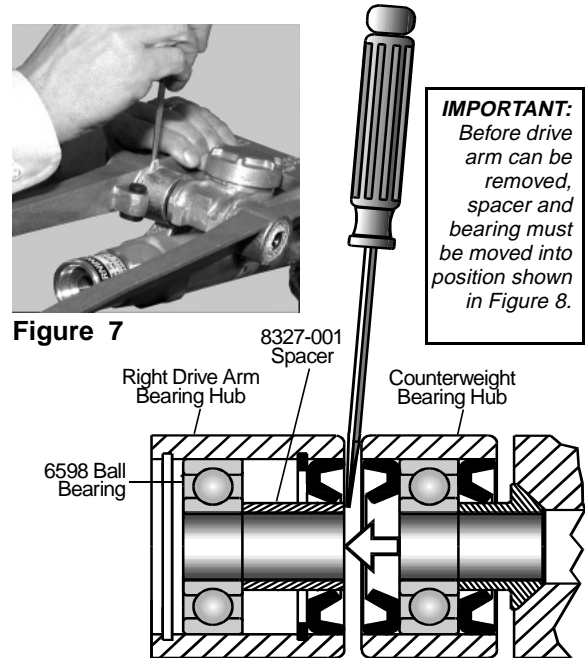
Figure 7

Figure 8

IMPORTANT: Before drive arm can be removed, spacer and bearing must be moved into position shown in Figure 8.

Insert blade of screwdriver between right drive arm bearing hub and counterweight bearing hub (see Figure 7). Work blade against 8327-001 spacer, and slide spacer and 6598 ball bearing in direction indicated by arrow in Figure 8. Rotate right drive arm bearing hub up and remove drive arm from Big Gun®.

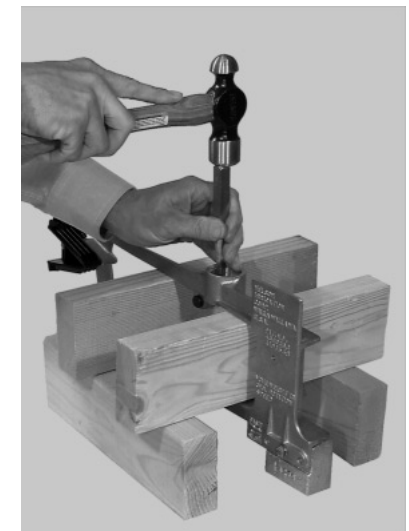
Figure 12

Support drive arm as shown in Figure 12. Drive 6600 seal out of hub with screwdriver (or punch) and hammer. Turn drive arm over and remove 6600 seal from opposite hub. Clean all foreign material from hub bores.

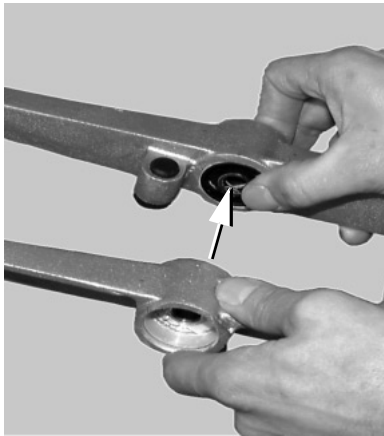
Figure 14

Insert new 8327-001 spacer into 6600 seal of right drive arm bearing hub (see Figure 14). Push spacer in until flush with lip of seal (see Figure 15). Pushing spacer in will also push bearing over. Insert new 6607-001 cone spacer into 6600 seal of left drive arm bearing hub. Install 6603 nut on shoulder end of 8297 drive arm shaft with washer face of nut towards shaft (see Figure 17 below). Screw nut all the way down threads and seat against shoulder of shaft.

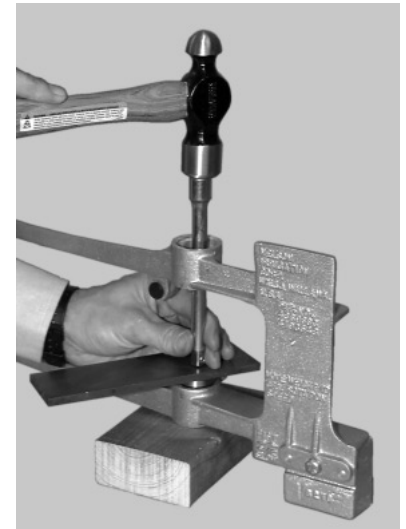
Figure 13

Support drive arm as shown in Figure 13. With lip of the seal facing up, position new 6600 seal over bore of lower hub. Place flat piece of smooth metal or wood on top of seal. Insert punch or similar tool through bore of upper hub and let it rest on piece of metal or wood. Tap lightly on punch with a hammer and drive seal squarely into bore of hub until lip of seal is flush with face of hub. Turn drive arm over and, in same manner, install new 6600 seal in other drive arm bearing hub.

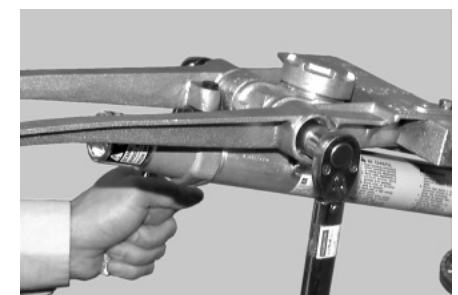
Figure 19

Insert new 6607-001 cone spacer into 6600 seal located on inner side of counterweight. While facing nozzle, hold counterweight in position on left side of gun. Grasp drive arm and hold vertically with drive vanes down and right drive arm bearing hub (side with black bumper) to left. Move drive arm into position around nozzle and range tube. Engage bearing hub with counterweight and roll other bearing hub into position on right side of gun. With finger pressure, push 6598 ball bearing and 8327-001 spacer to right and into position shown in Figure 16. Push 8297 drive arm shaft through bore of assembled components (see Figure 18). Install 6603 nut onto shaft with washer face of nut towards shaft (see Figure 17). As shown in Figure 19, torque nut to 25 ft-lbs (34 N-m).

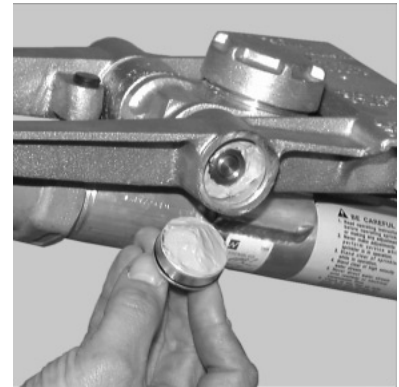
Figure 20

Pack both drive arm hubs with Lubriplate® 130-AA lubricant (see Figure 20). Install new 6563 O-rings on 6602 caps and fill both caps with same lubricant. Using finger pressure, press caps into drive arm hubs. Excess lubricant will be forced out past seals and will purge hubs of air. Install one 6565 retaining ring in each hub.

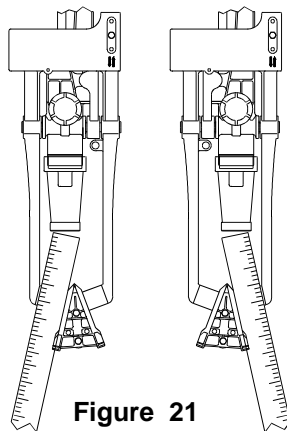
Figure 21

Place steel ruler against drive vane in lowest slot of vane. Push drive arm fully over to one side and slide ruler until it touches nozzle (see Figure 21). Note location where tip of ruler touches nozzle. Repeat on other side. **The points where ruler touches each side of nozzle should mirror each other.**

IMPORTANT: Side to side bend may cause faster drive in one direction.

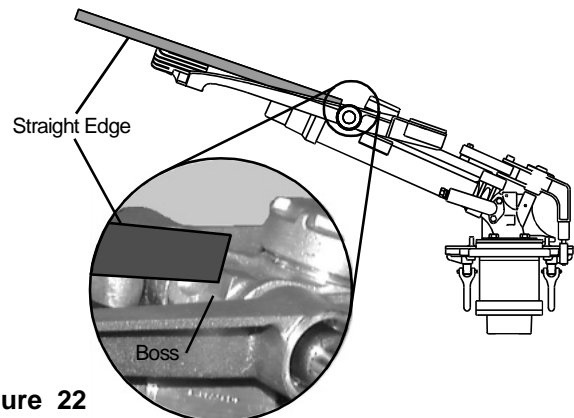
Figure 22

Lift drive arm up to its resting position. Lay a straight edge perfectly flat on top of drive vane (see Figure 22). Slide straight edge against rectangular boss. **Lower corner of straight edge should contact boss half way up its vertical face.**

IMPORTANT: Vertical bend may cause weak drive action or cause drive vane to hang in stream.

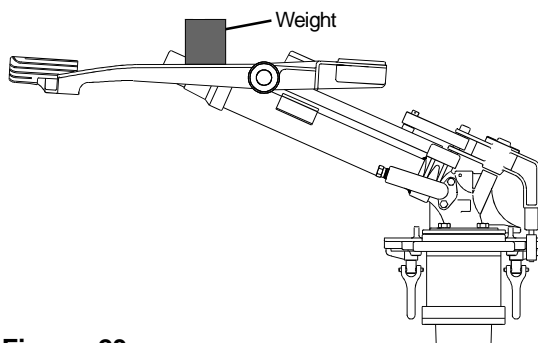
Figure 23

Using a weight as shown in Figure 23, balance drive arm in horizontal position. After drive arm is balanced, tap the drive vane downward with fingers. **The drive arm should fall smoothly without binding.**

IMPORTANT: Sticky arm bearings and seals may cause drive arm to hang in bottom of stream. Replacement of drive arm bearings and seals may be necessary to achieve adequate arm stroke.
